Seaside Home Inspection
8 Cranberry Knoll Court
Bourne MA 02532
774-392-2252
seasidehomeinspection@gmail.com
Report: 2-25-2016-044

Confidential Inspection Report **Menemsha Public Restrooms** **Chilmark, MA**

February 25, 2016

Prepared for: Town Of Chilmark

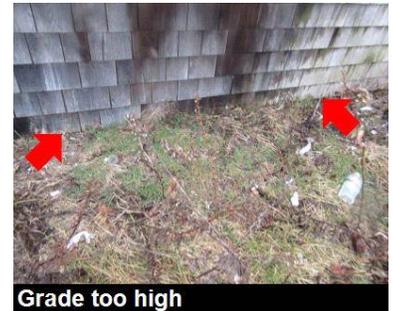
NEAR BUILDING WALL: The grade is just above the bottom of the siding near the front and right side and rear of the building. I recommend that the grade be lowered to allow 6" of the foundation wall to show above grade. I also recommend that the grade slope away from the home at a minimum of 1" per foot for five feet away from the wall.

Grade too high

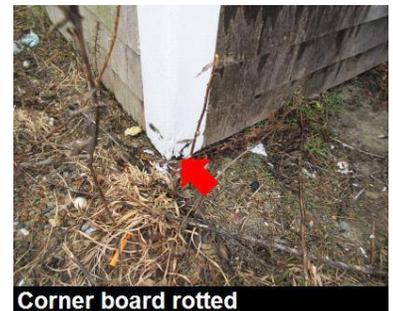
GENERAL TRIM CONDITION: The right front corner board is rotted and should be replaced by a qualified trim carpenter.

Corner board rotted

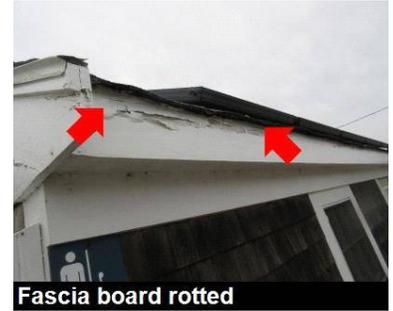
The front Fascia board is rotted and I suspect additional concealed damage to the wooden members of the home. A qualified contractor should be consulted to further evaluate the eave, soffit, fascia and sheathing for additional concealed damage and to replace all rotted wood as necessary. If insect damage is found, a pesticide applicator is needed to determine if an insect treatment is needed.

Fascia board rotted

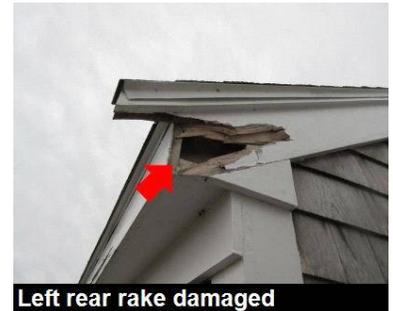
The end of the left rear rake board is damaged. We A contractor is needed to replace the rotted wood and cover the end of the rake board with roof shingle or flashing to prevent future water damage.

Left rear rake damaged

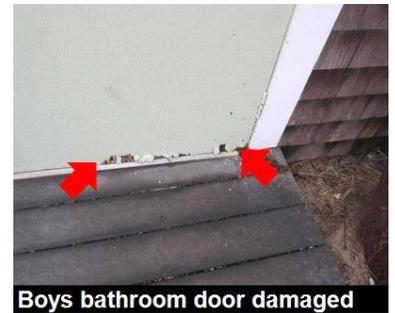
LEFT SIDE DOORS

CONDITION: The door is damaged or rotted and should be replaced by a Licensed Construction Supervisor.

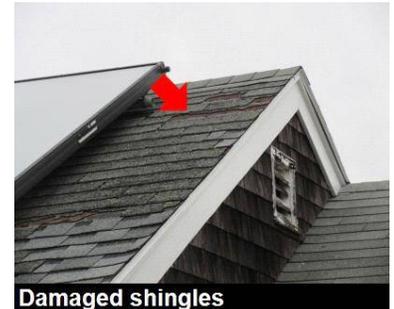
There are several missing or damaged shingles noted. TYPICAL MAINTENANCE IS RECOMMENDED. This usually consists of repair/replacement of damaged/missing shingles. This maintenance should help insure the weather tightness of the building and should be performed on a regular basis as needed.

The roof covering is brittle or cupped, is fully depreciated and has exceeded its useful life. This condition indicates advanced age that may cause concealed water damage to the roof sheathing located below the roof covering without signs of interior leaks. The roof covering should be further evaluated by a qualified roofer for immediate replacement.

ROOF COVERING CONDITION: There are several missing or damaged shingles noted. TYPICAL MAINTENANCE IS RECOMMENDED. This usually consists of repair/replacement of damaged/missing shingles. This maintenance should help insure the weather tightness of the building and should be performed on a regular basis as needed.

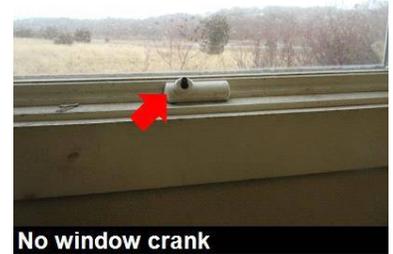
The female rear bathroom stall window cranks are missing and should be installed by a contractor.

The left side bathroom window hand operating window crank or mechanism is damaged or stripped. A window replacement technician is needed to replace or repair all hardware as necessary.

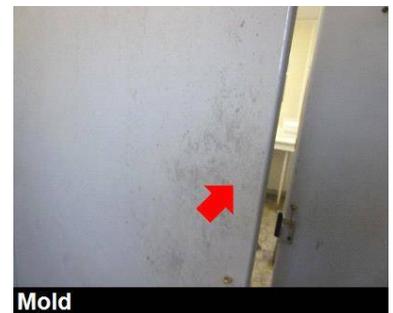
A substance that resembles mold is present on the female bathroom stall door and I suspect high relative humidity may be the cause.
