July 10, 1991

Subject: Route M - Chilmark - Permit No.7-22034

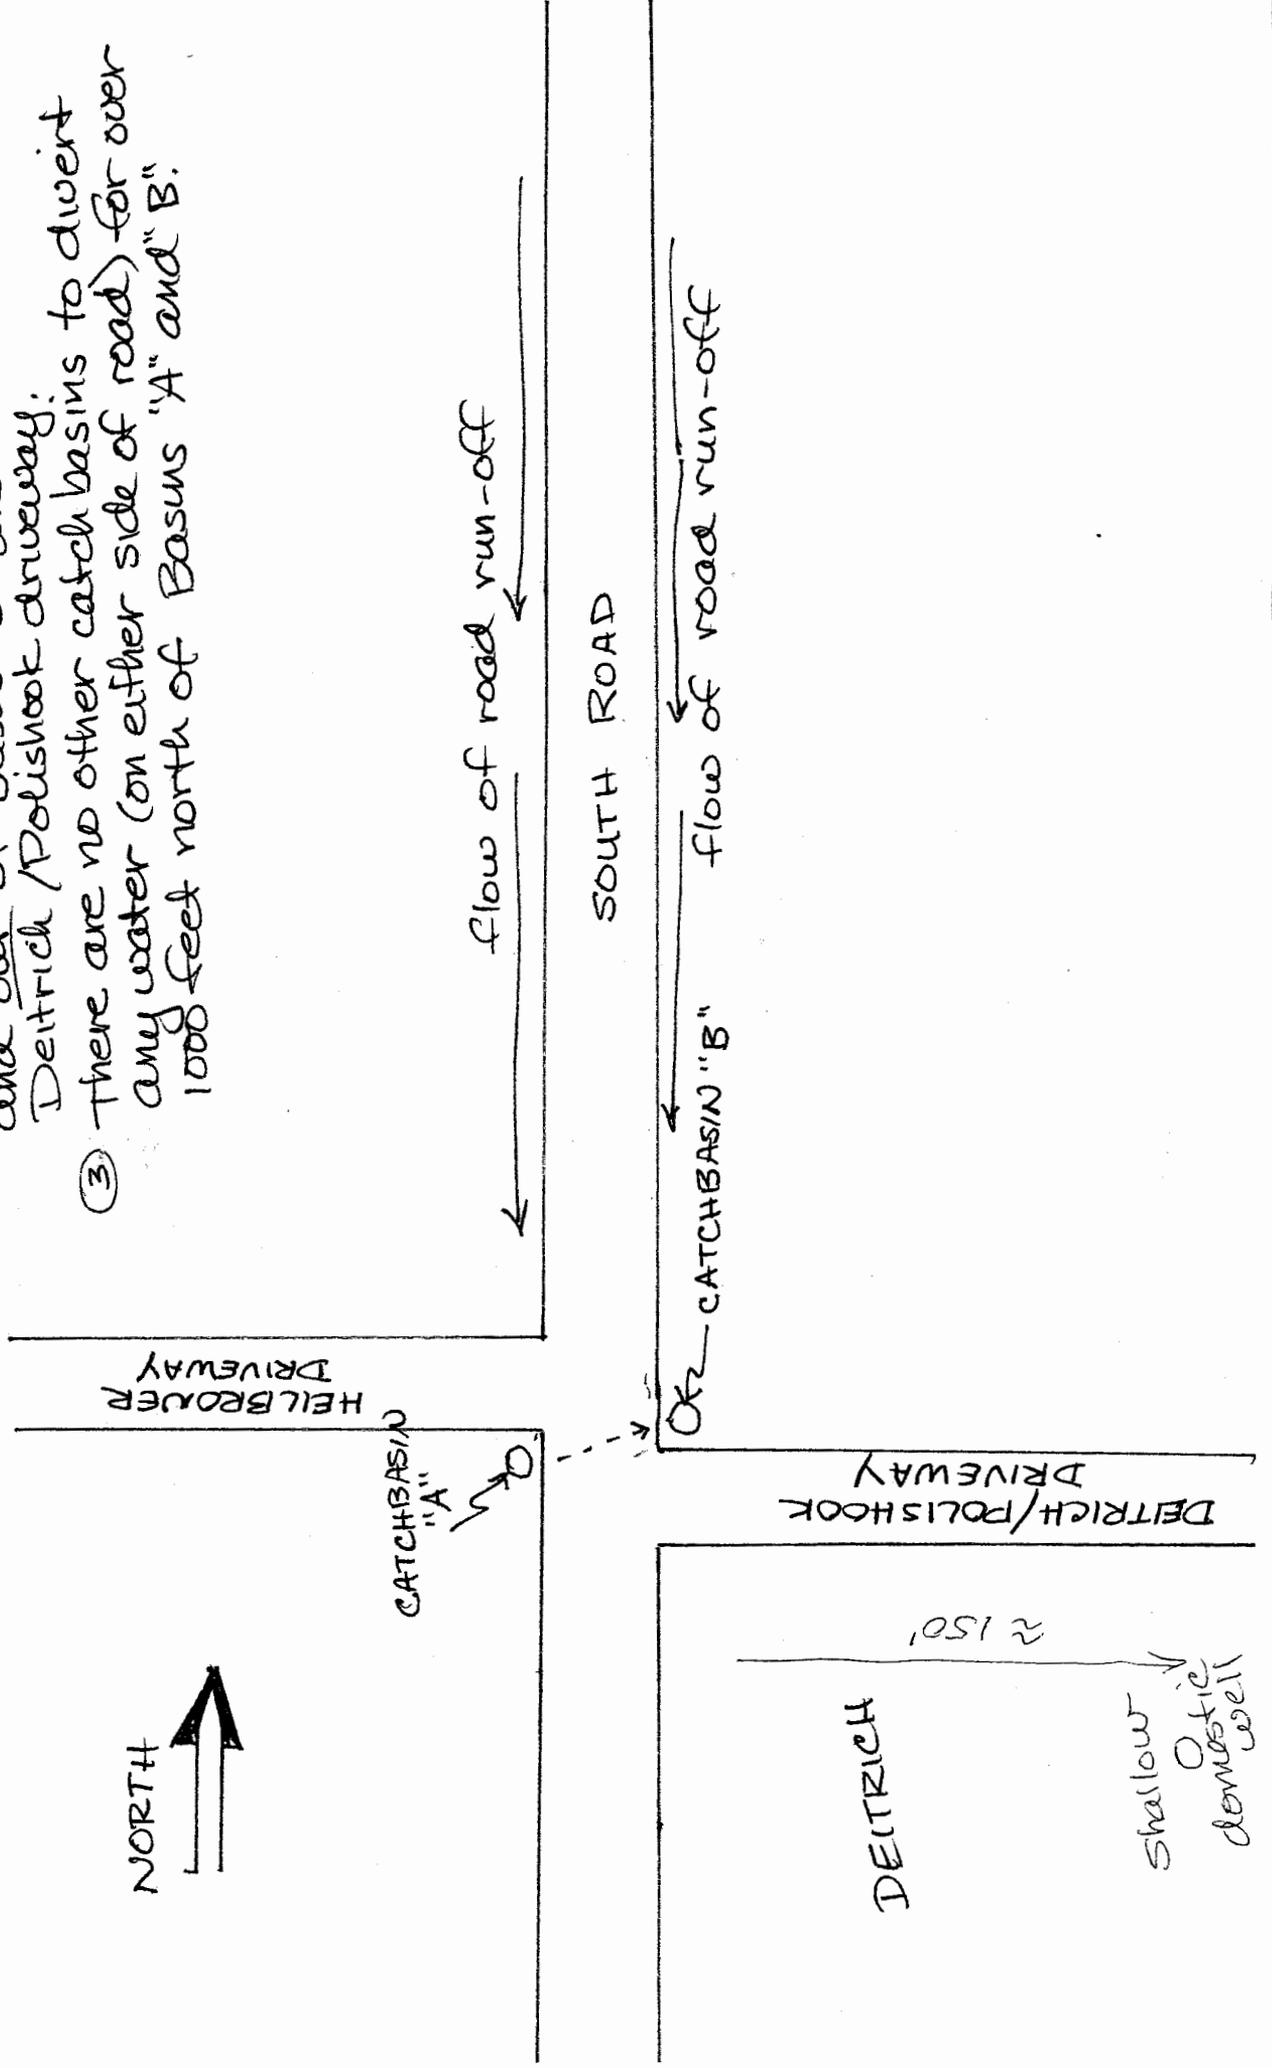
- ① Catch basin "B" is immediately north of Deitrich/Polishook driveway and overflows into driveway.
- ② Road run-off on west side of South Road flows into Basin "A" and then under road and out of Basin "B" and into Deitrich/Polishook driveway.
- ③ There are no other catch basins to divert any water (on either side of road) for over 1000 feet north of Basins "A" and "B".

Attached is a rough sketch of the area in question. The catchbasins, as shown, overflow very quickly. We need to have your office send an engineer to look at the situation and come up with a plan to divert some of the water before it reaches our driveway. Paving the apron of our drive before such diversions are in place will only compound the problem we've been having.

The runoff water washes out our driveway as well as ending up near where our household well is located. We are concerned about road contaminants getting into our drinking water.
